# UNDERWATER BRIDGE INSPECTION REPORT

STRUCTURE NO. 7137

CR NO. 32

WATSON SAG CHANNEL

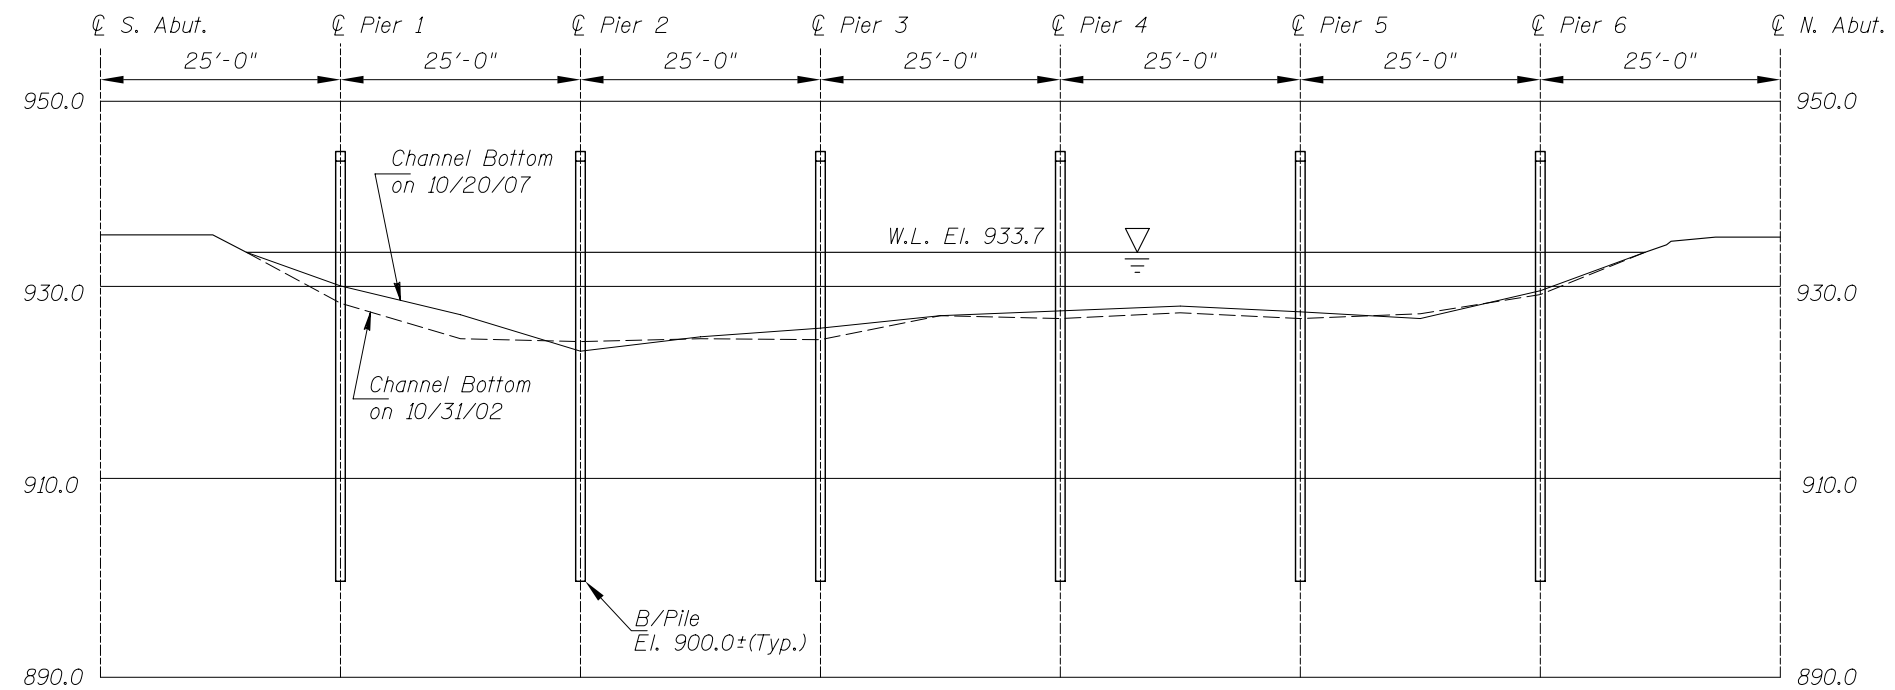
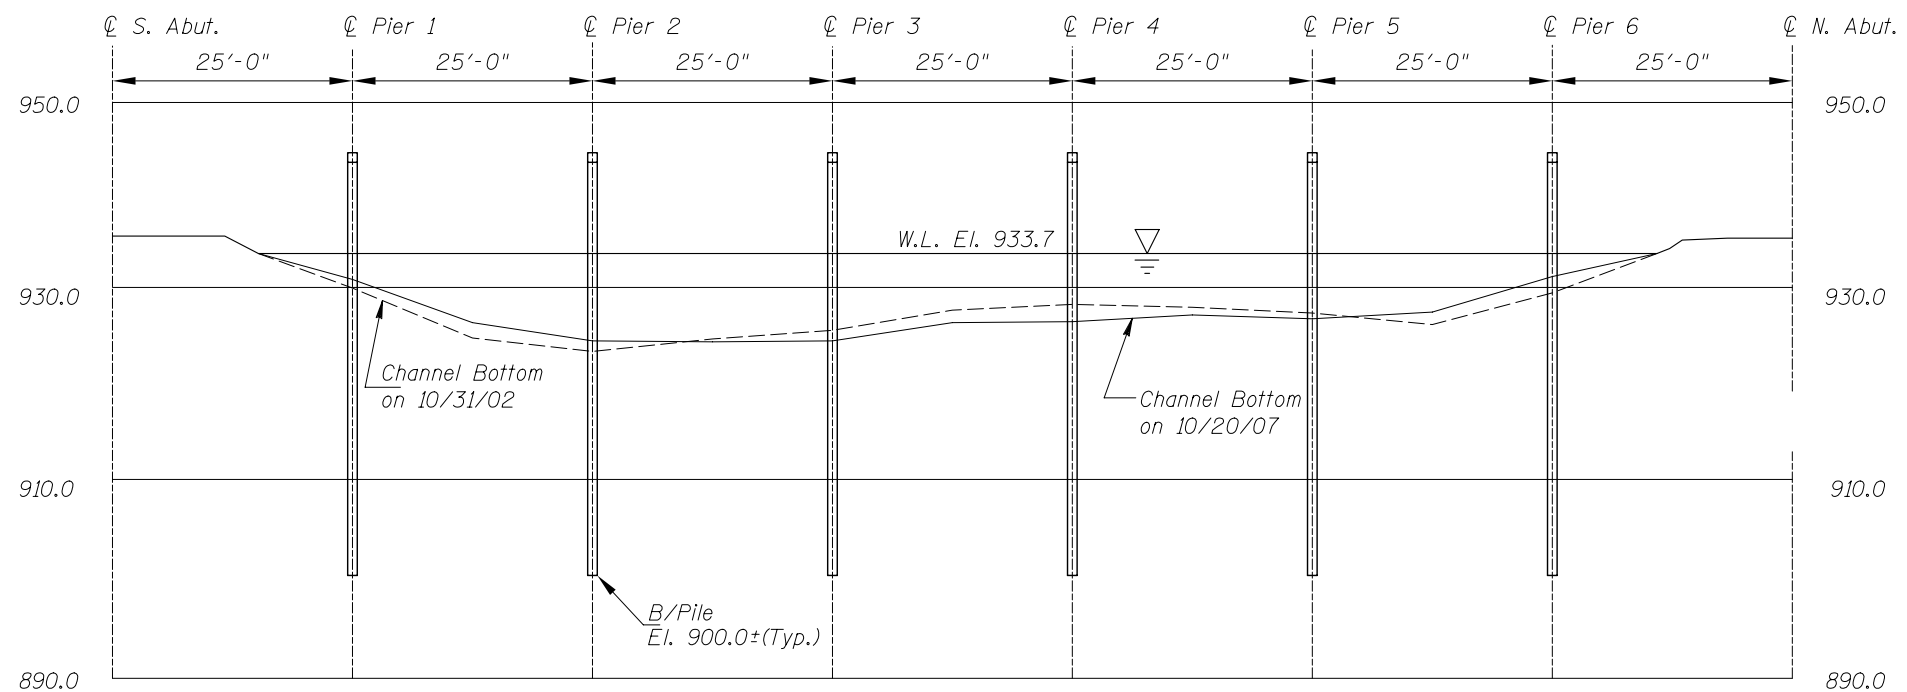
**INSPECTION AND SOUNDING PLAN**

- 1 The channel bottom material consisted of sandy silt and scattered 6 inch diameter stones with up to 3 inches of probe rod penetration.
- 2 Light corrosion was observed on the steel piles from 3 feet above the waterline to the channel bottom with random minor pitting having a maximum penetration of 1/16 inch.

- 3 Minor splitting and checking of the timber piles was observed from the pier cap to the channel bottom with a maximum width of 1/4 inch and a maximum penetration of 1 inch.

- 4 Diagonal timber bracing was split through the fastener (1/4 inch width typically).
- 5 Abrasion damage observed on the timber pile, from 1 foot above the waterline to 2.5 feet below the waterline, approximately 8 inches wide with a maximum penetration of 0.5 inch, and pile section loss at 10%.

- 8 Split in pile, from the pile cap to 2 feet above the waterline with a maximum width of 3/4 inch and 2 to 3 inches of penetration.
- 9 Diagonal bracing broken and no longer attached to pile.
